**Coal Combustion Residue Impoundment
Round 9 - Dam Assessment Report**

Cliffside Steam Station

Ash Basin Dikes

Duke Energy Corporation
Moorestown, North Carolina

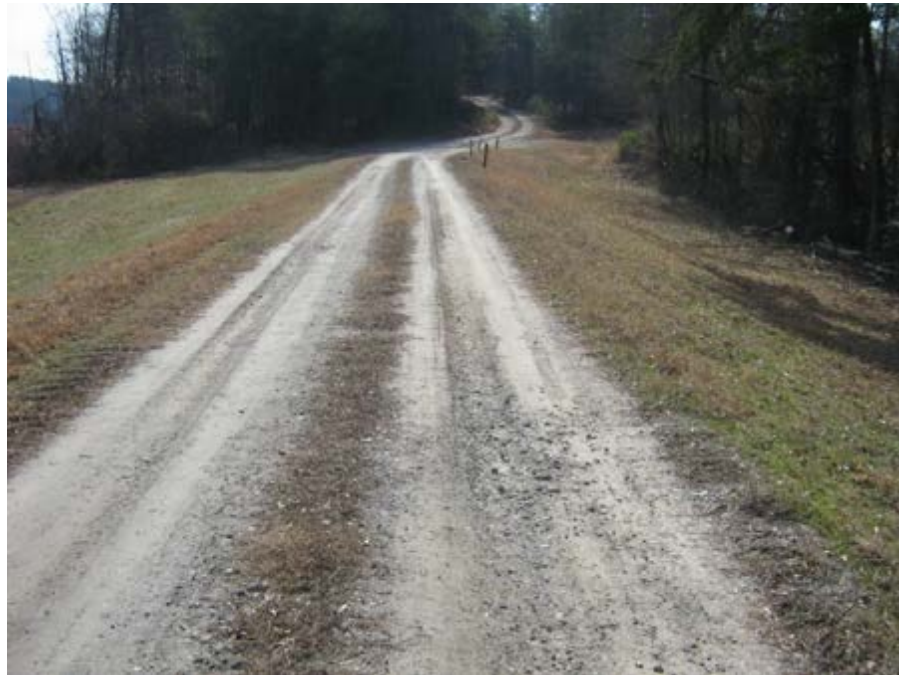
There was minor rutting along the upstream dike, left abutment crest. Overall, there were no signs of depressions, tension cracking, or other indications of settlement or shear failure and the crest appeared to be in satisfactory condition.

Minor Rutting Along Crest at Left Abutment

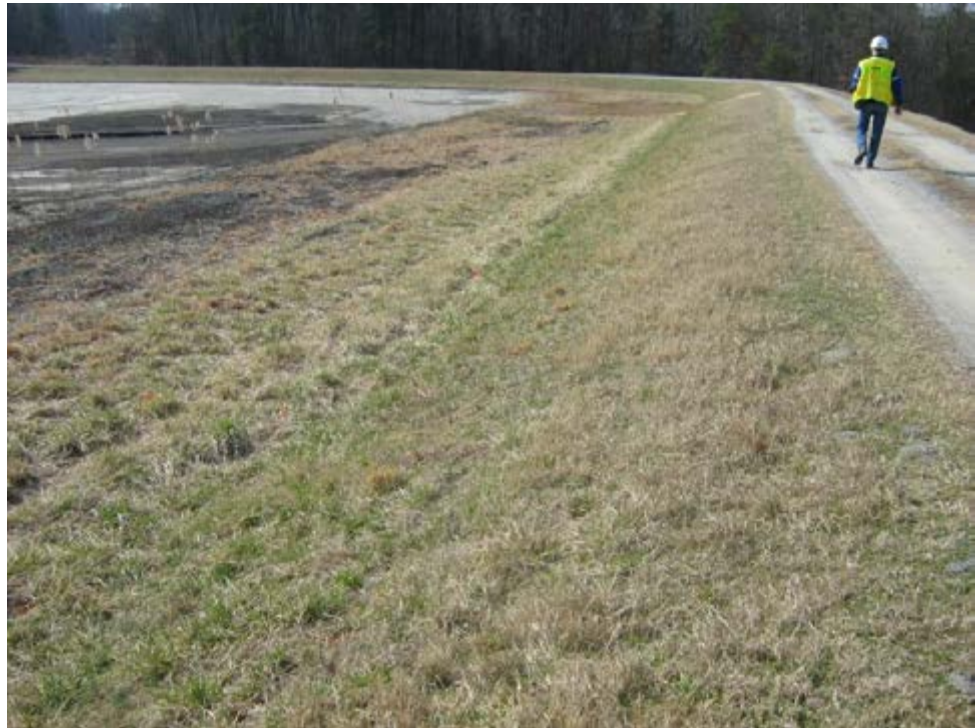
No scarps, sloughs, depressions, bulging or other indications of slope instability or signs of erosion were observed. There was an isolated area that had recently been repaired and was covered with an erosion control fabric.

Upstream slope

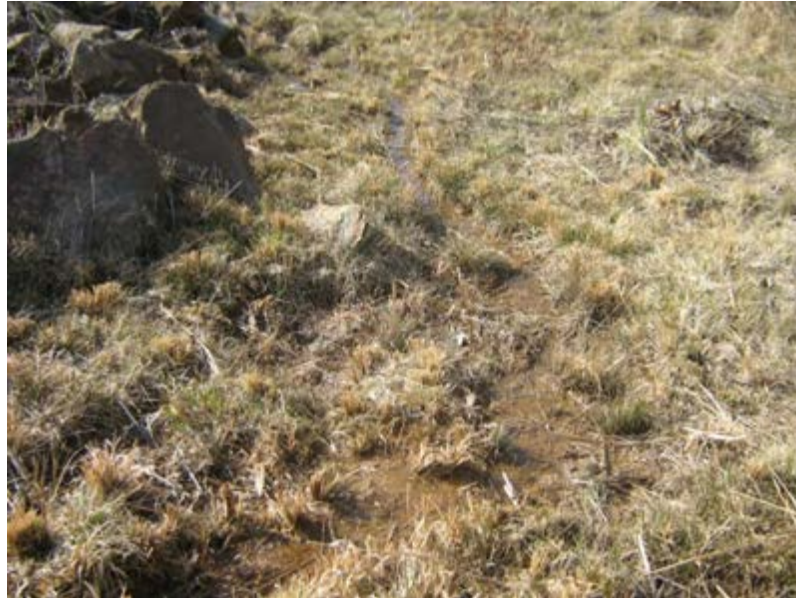
Widespread seepage was observed along the toe. No scarps, sloughs, depressions, bulging or other indications of slope instability or signs of erosion were observed.

Widespread seepage along toe

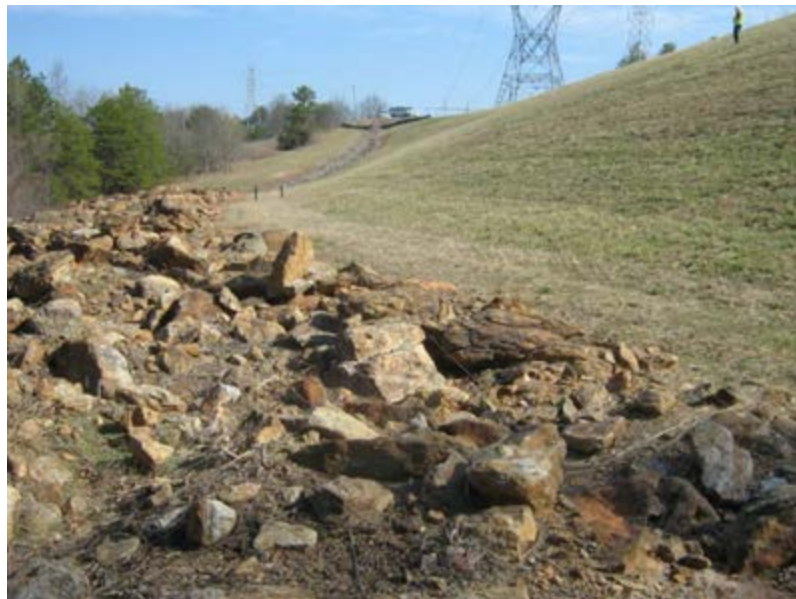
The abutments and groin areas of the dike appear to be in satisfactory condition.

Right Abutment

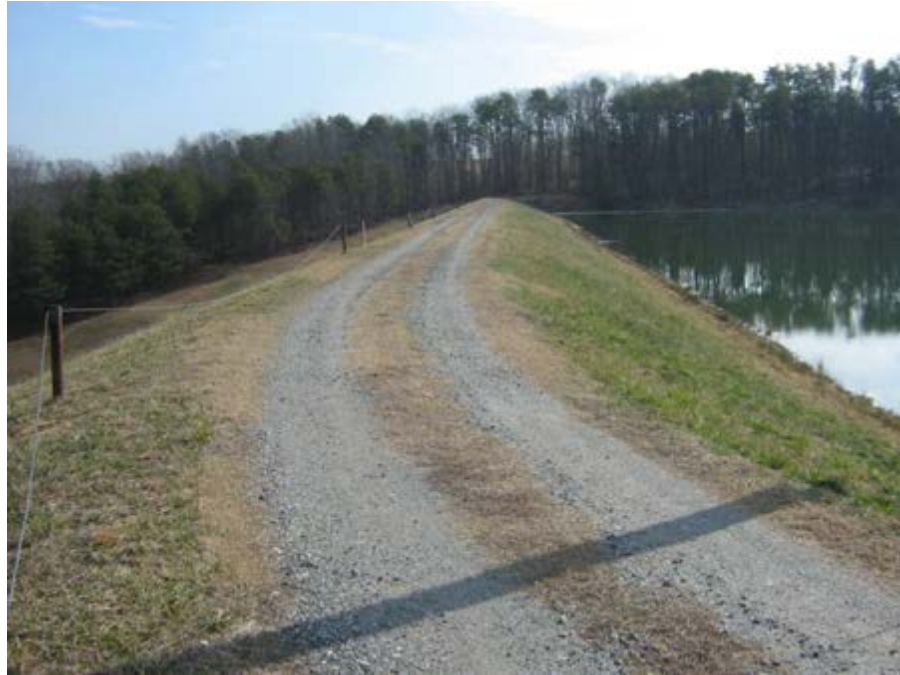
No scarps, sloughs, depressions, bulging or other indications of slope instability or signs of erosion were observed.

Downstream Dike Crest

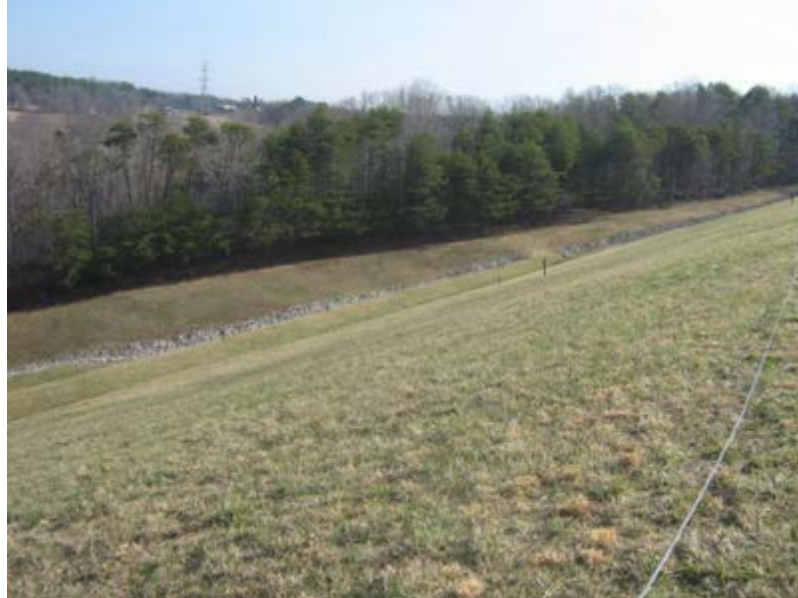
No scarps, sloughs, depressions, bulging or other indications of slope instability or signs of erosion were observed. Seepage was observed at the toe of the slope in the vicinity of the internal blanket drain.

Overall View of Downstream Slope

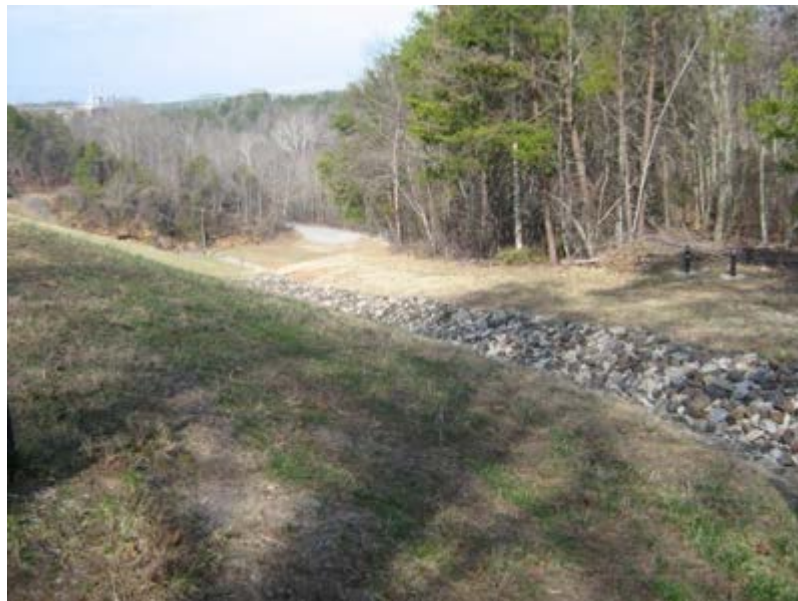
The abutments and groin areas of the dike appear to be in satisfactory condition.

Right Abutment

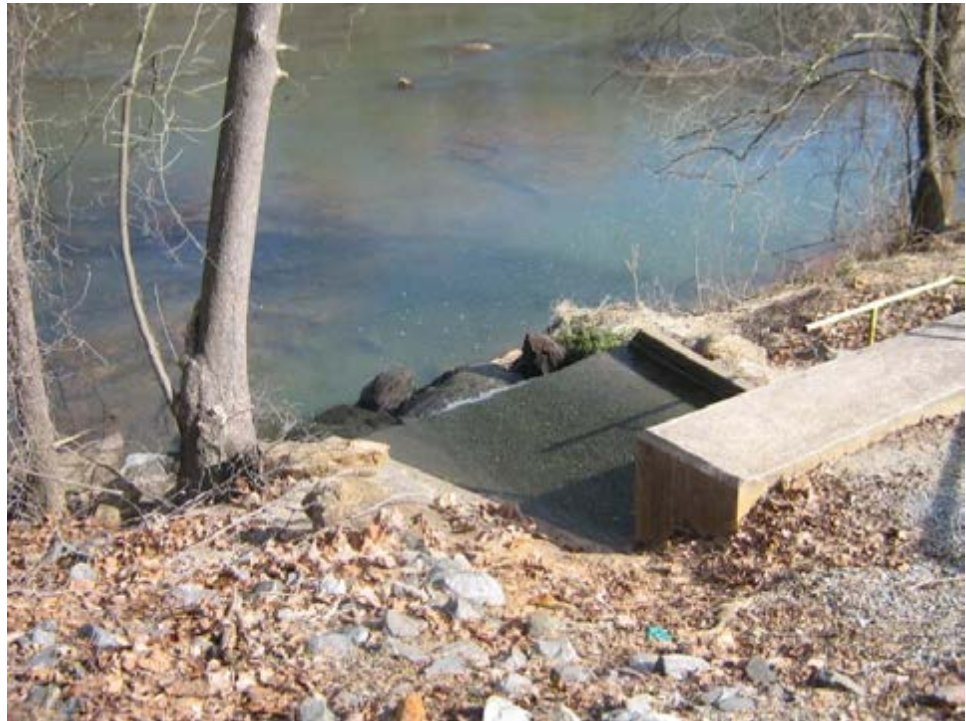
The visual portion of the outlet conduit was functioning properly with no apparent deterioration.

Outfall into Broad River

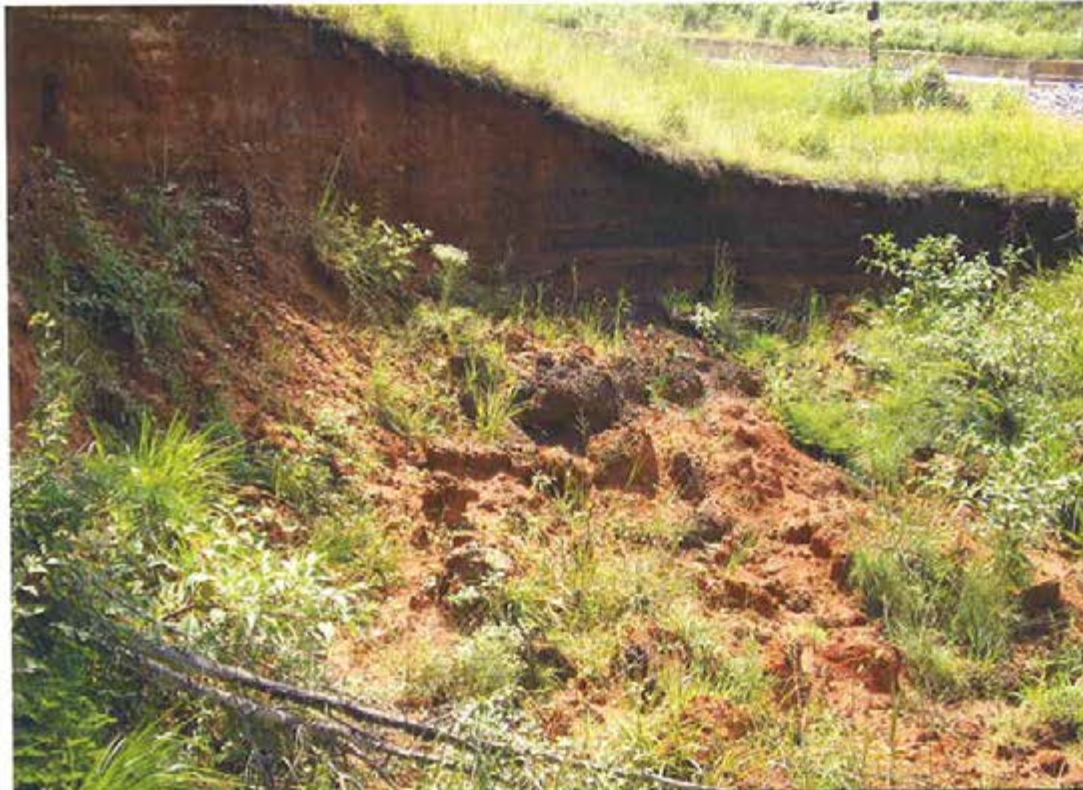
Photograph 4-4A

Failed and eroded area of downstream slope and toe of Units 1-4 old ash basin dike, at about dike centerline station 3+00.

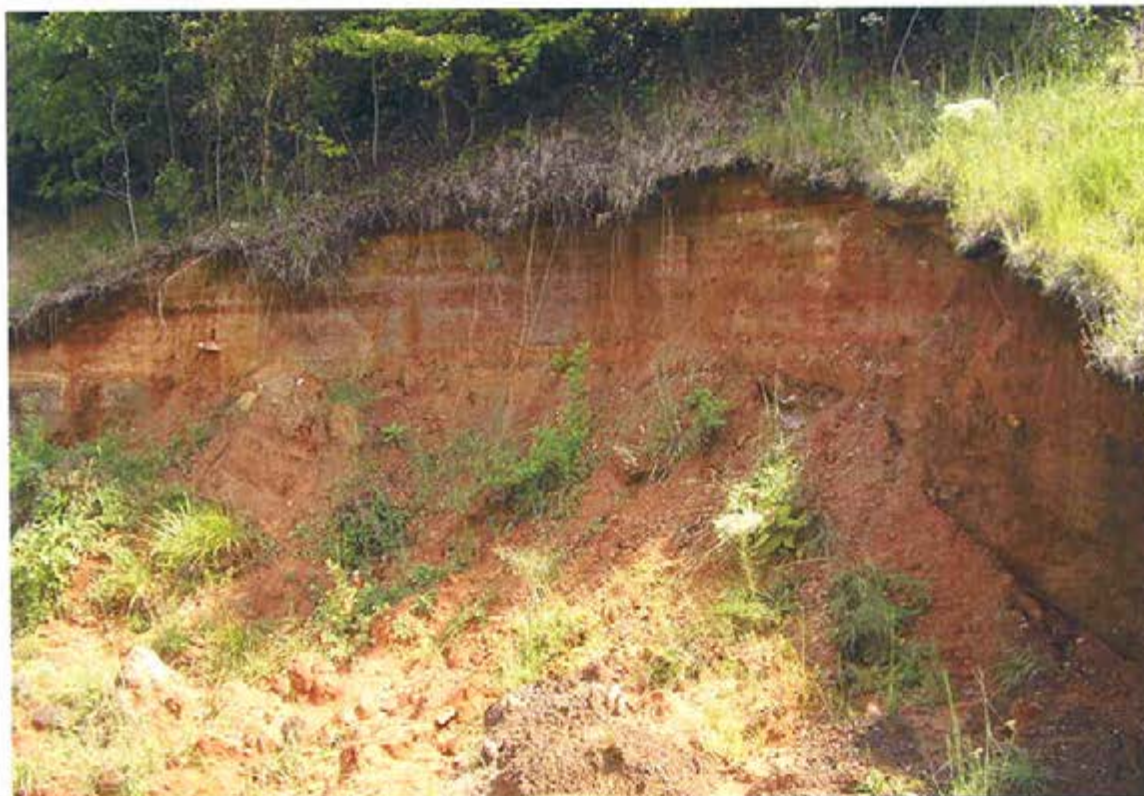
Photograph 4-4B

Failed and eroded area at station 3+00 viewed looking toward the Units 1-4 old ash basin dike centerline.

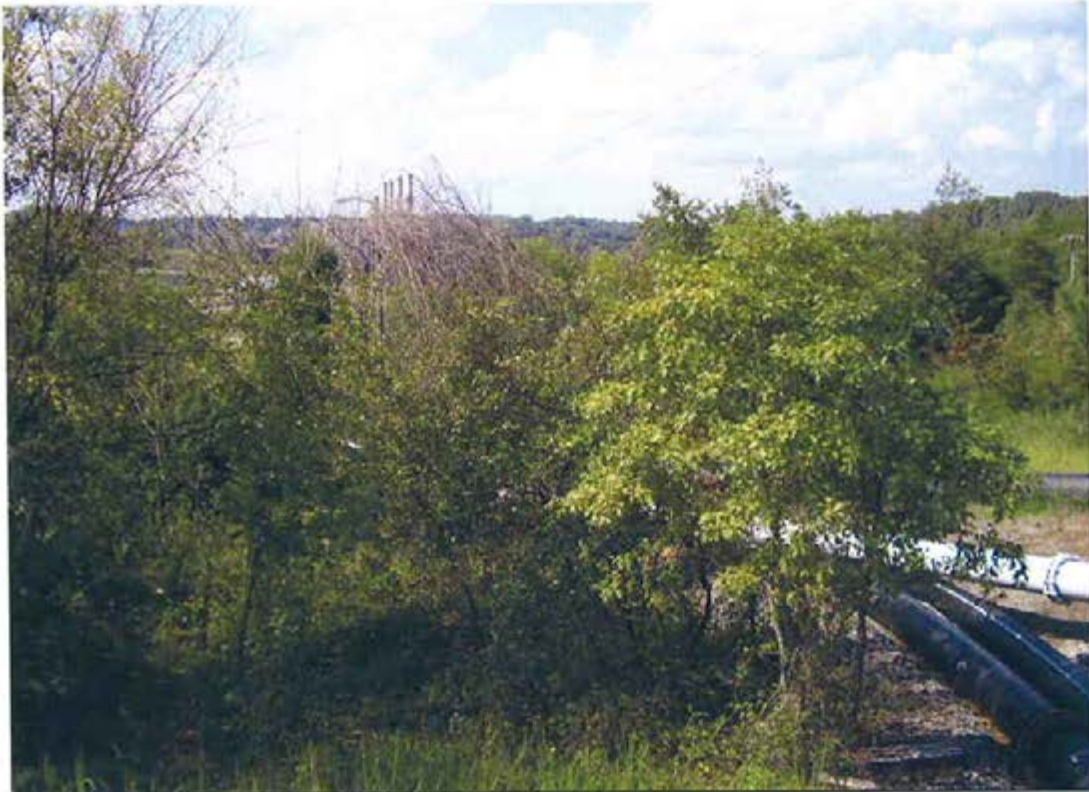
<p>Photograph 4-5</p> <p>Tree growth obscures yard drainage holding pond and dredge spoil pond in Units 1-4 old ash basin area from viewpoint of 2001 inspection photograph.</p>
	Remarks

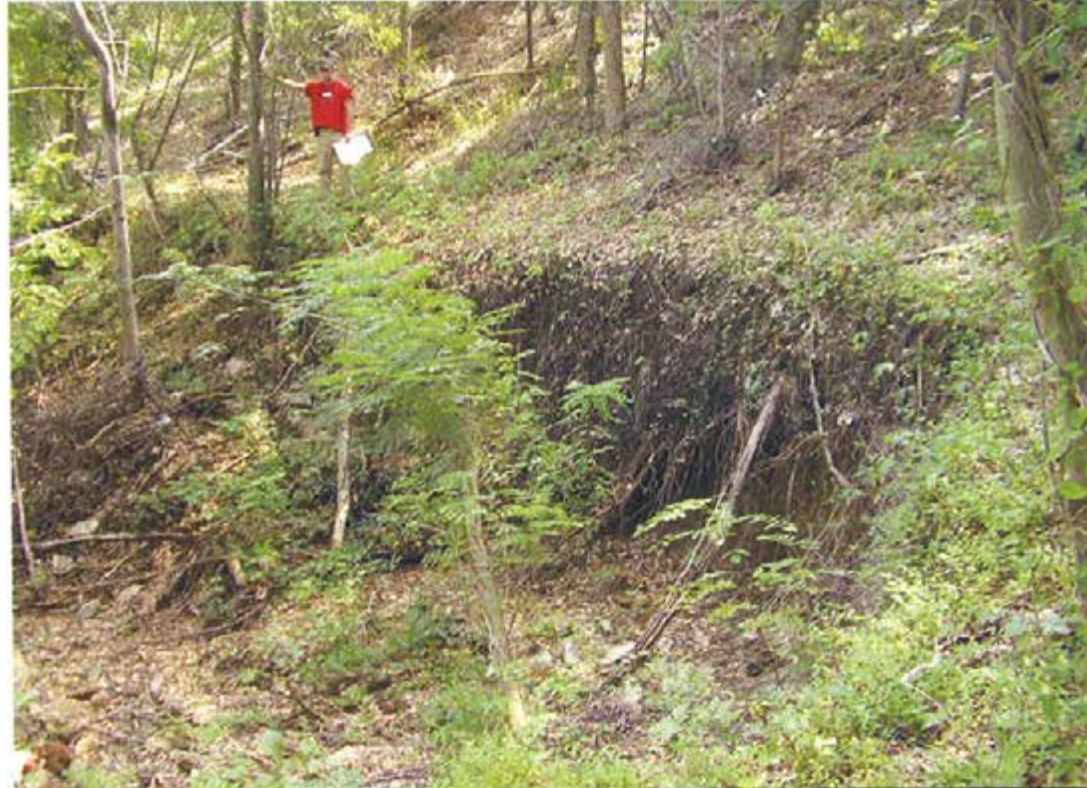
<p>Photograph 4-6C</p> <p>Failed and eroded lower portion of downstream slope of Units 1-4 old ash basin, about 15 ft deep, extending from about station 6+50 to 8+50.</p>

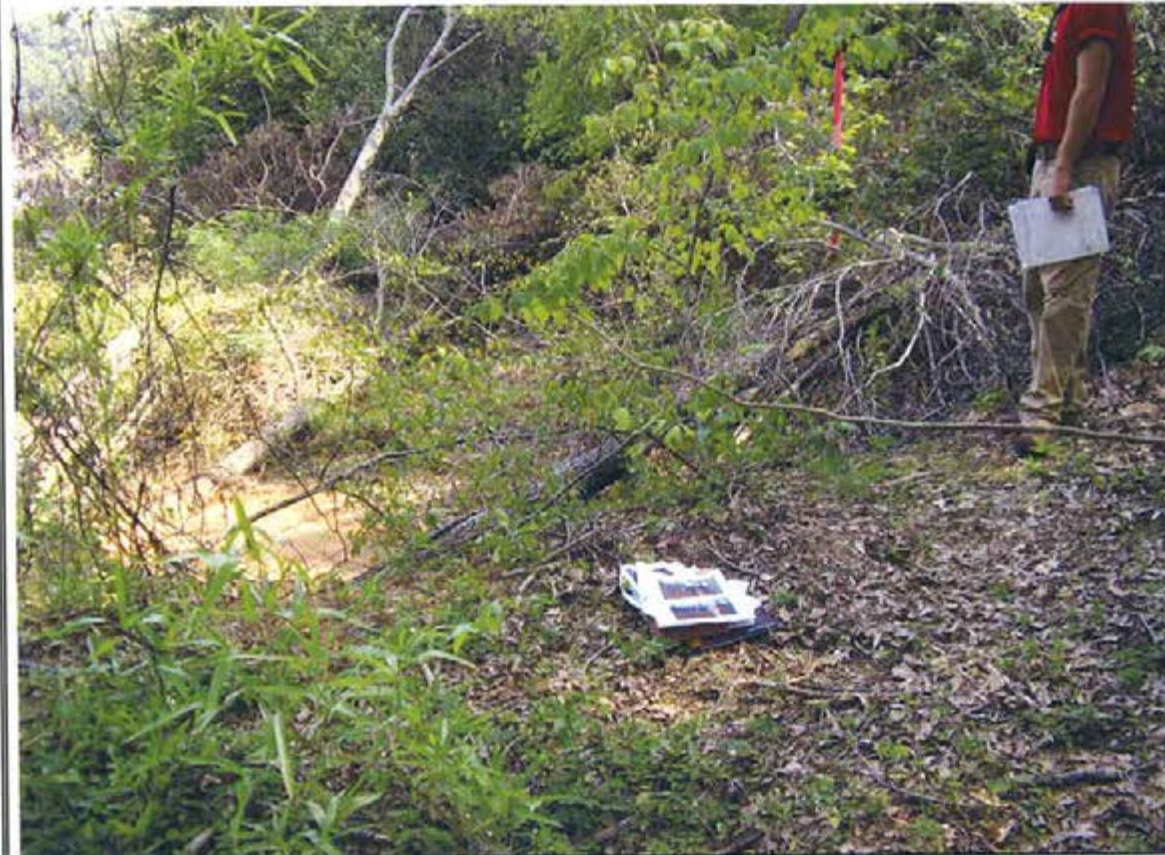
Photograph 4-7B

Approximately 20 ft deep failed and eroded area at downstream slope and toe of Units 1-4 old ash basin dike at about station 11+00.

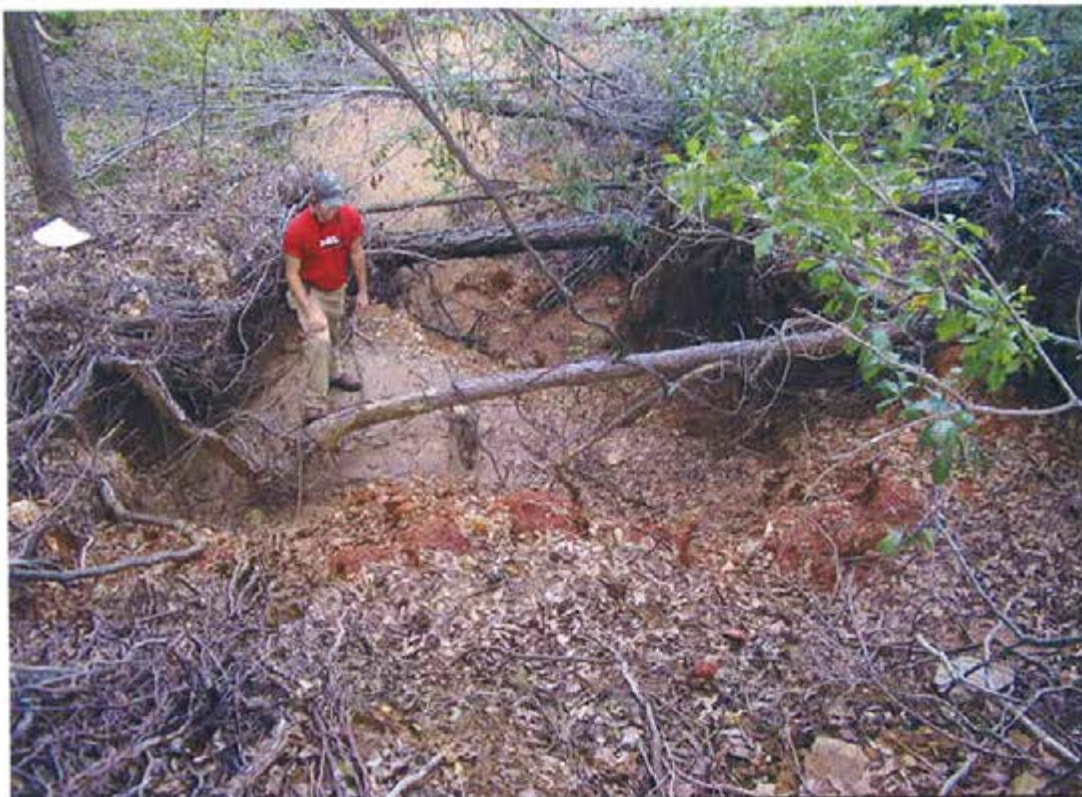
Photograph 4-7C

Failed and eroded area of photograph 4-7B, viewed from above.

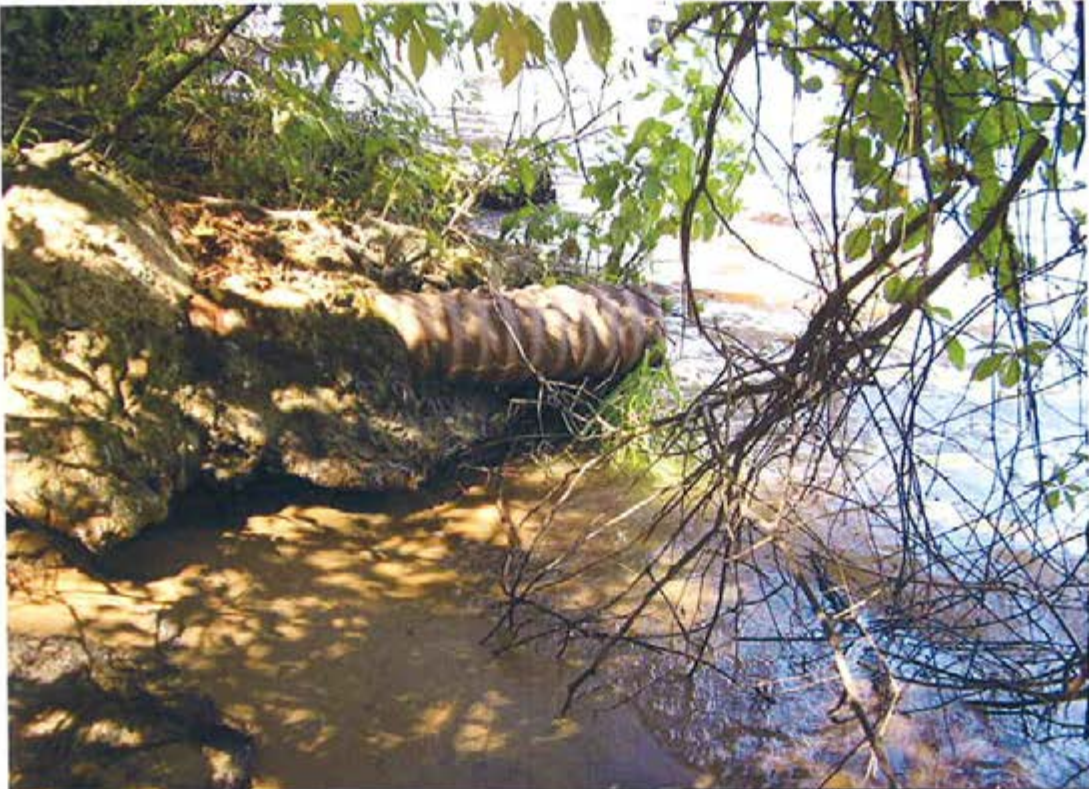
<p>Photograph 4-8</p> <p>Drain pipes at edge of river below toe of outside slope of Units 1-4 old ash basin dike. Ground has eroded more below concrete since last inspection.</p>
	Remarks

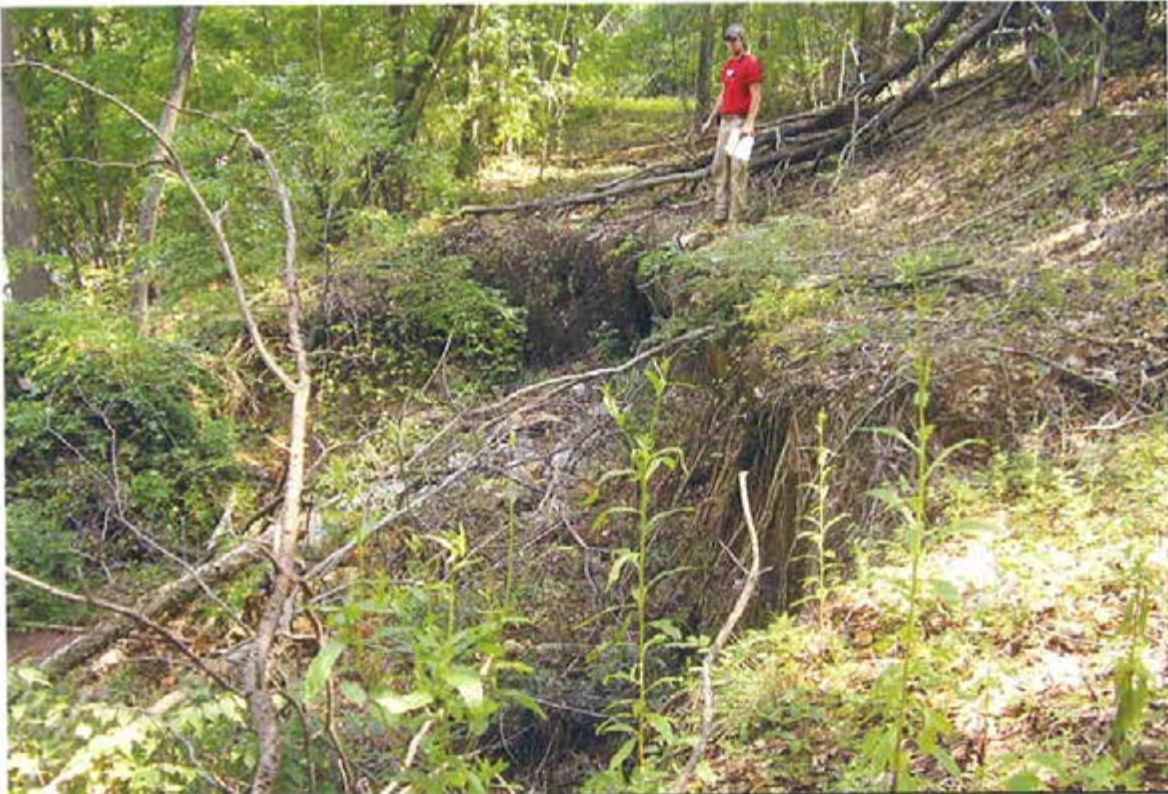
<p>Photograph 4-8A</p> <p>Failed and eroded lower downstream slope of Units 1-4 old ash basin dike at about station 8+00.</p>

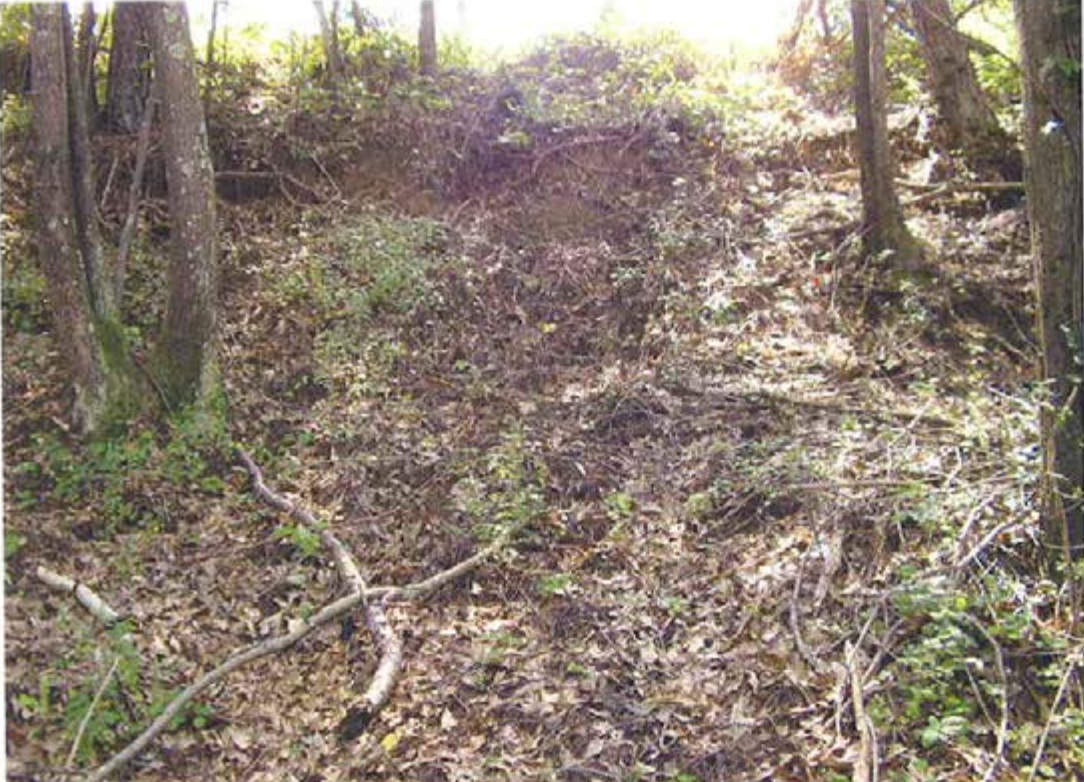
<p>Photograph 4-8B</p> <p>Apparent old slump/eroded area on upper portion of downstream slope of Units 1-4 old ash basin dike, above recent failure area of photograph 4-8A.</p>
	Remarks

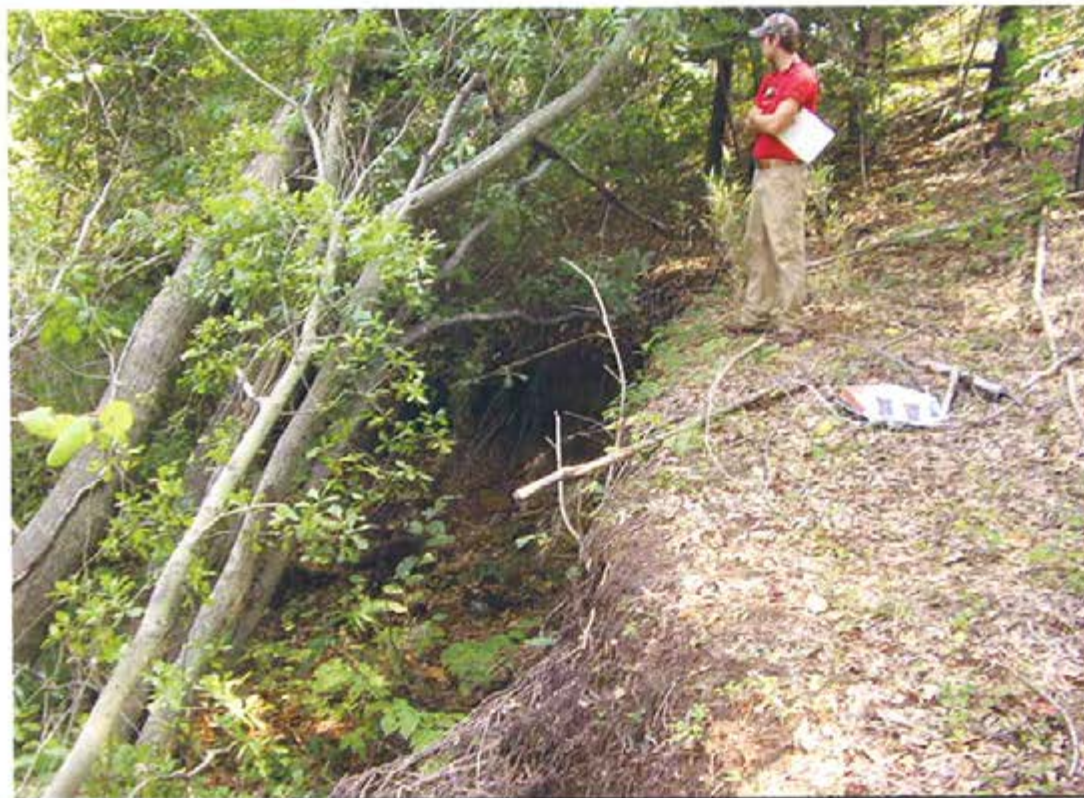
<p>Photograph 4-8C</p> <p>Failed and eroded lower downstream slope of Units 1-4 old ash basin dike, at about station 10+00.</p>

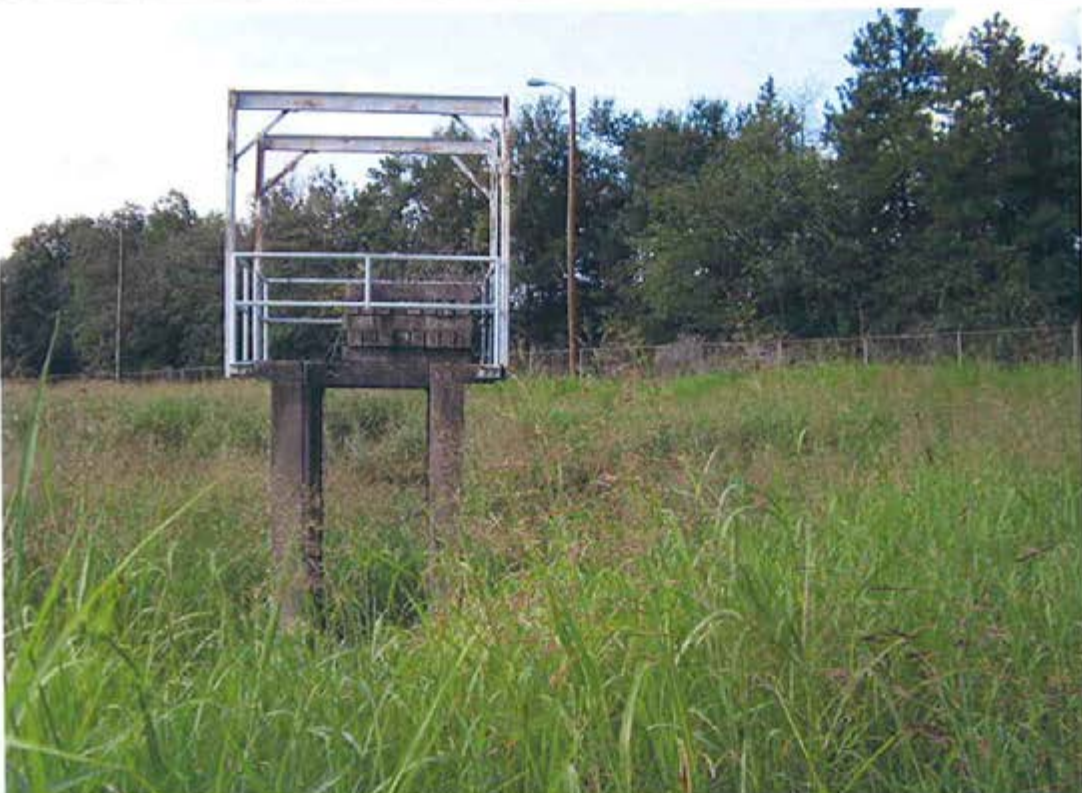
<p>Photograph 4-9</p> <p>View of Units 1-4 old ash basin drainage tower. High grass obscures the ground surface.</p>
	Remarks

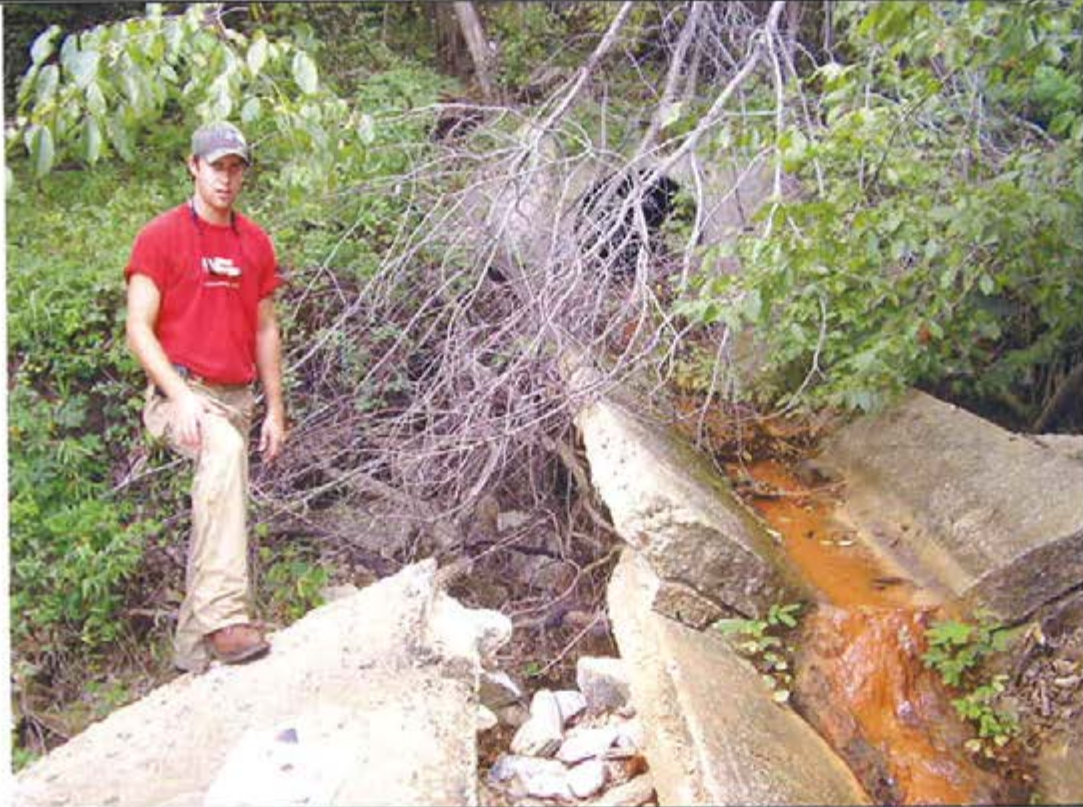
Photograph 4-10A
Severe erosion under and damage to concrete flume of 30 inch CMP outlet for Units 1-4 old ash basin.

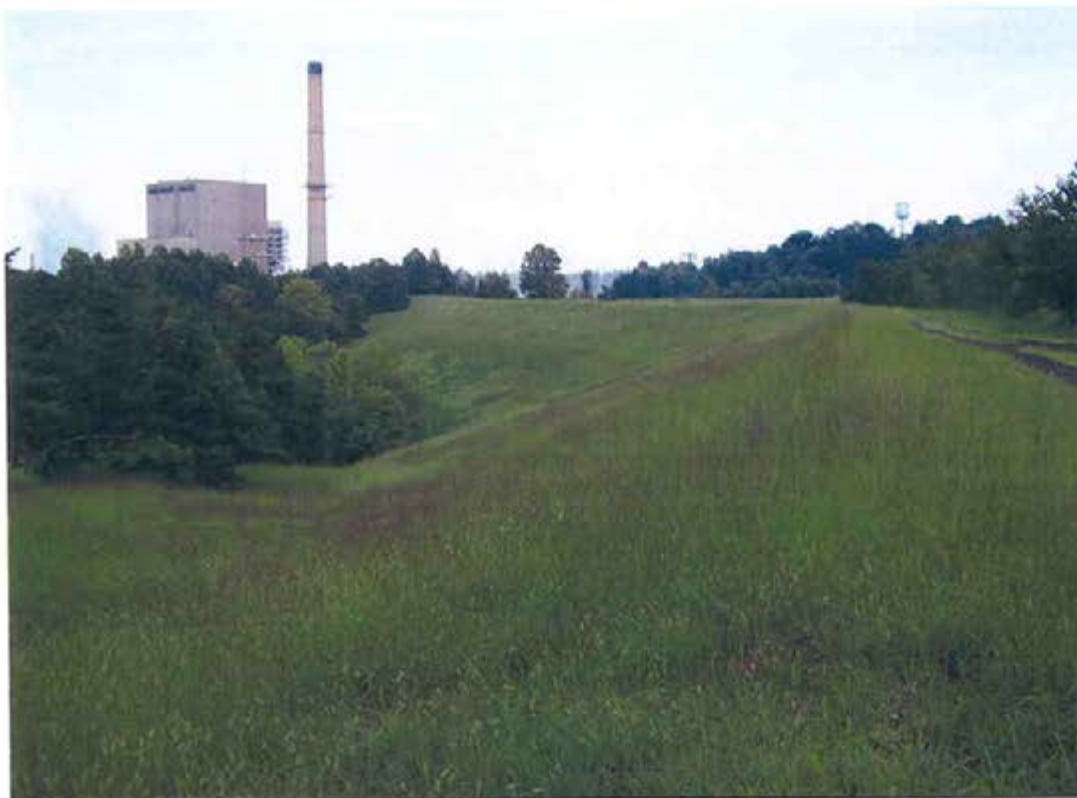
Photograph 4-11
Outside (downstream) slope of unit 5 retired basin main dike. Slope surface obscured by high grass.

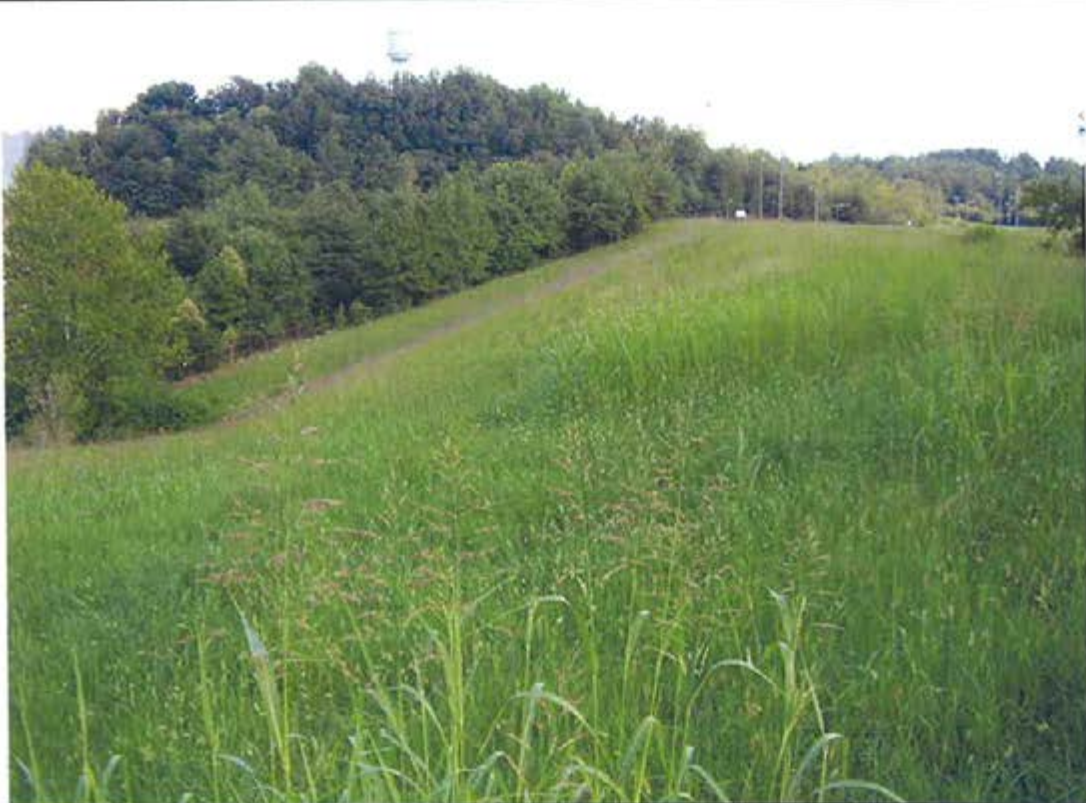
<p>Photograph 4-12B</p> <p>Downstream slope of saddle dike for unit 5 retired basin above cooling tower B. No seepage observed in overgrown low area. High grass obscures slope surface.</p>
	Remarks
	<p>Photograph 4-13</p> <p>See photograph in 1991 Inspection Report.</p>

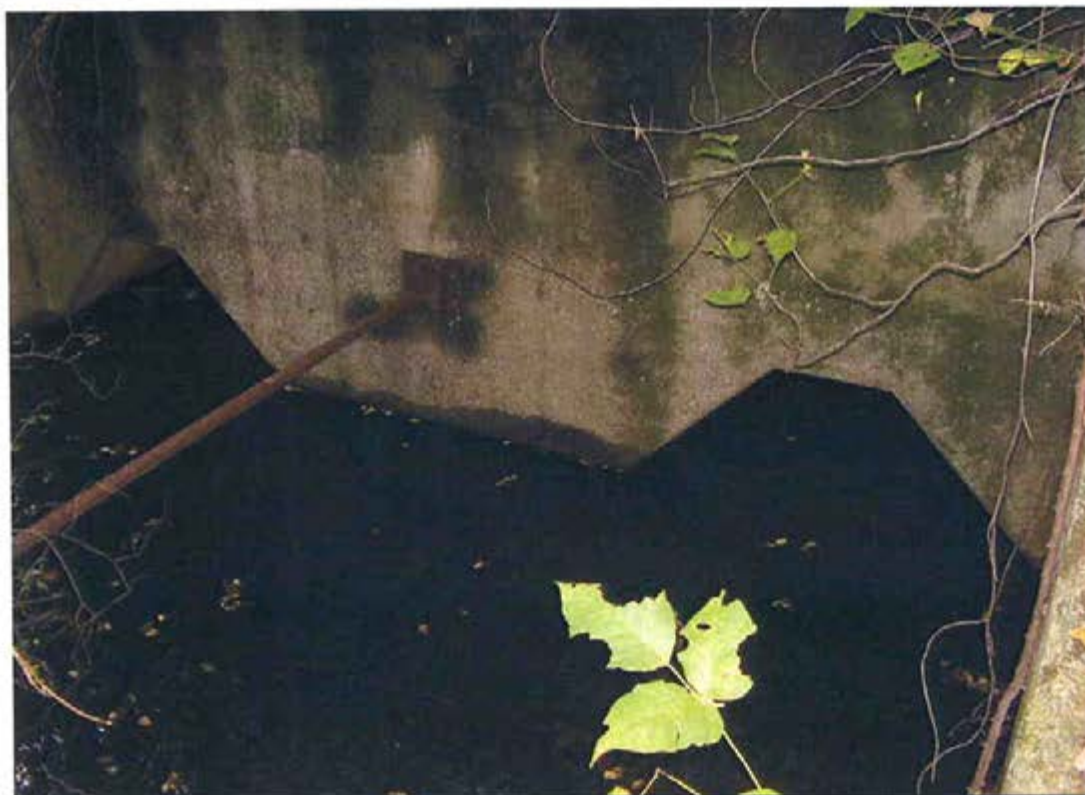
Photograph 4-14

Outlet end of 60-inch
RCP outlet for unit 5
retired ash basin.

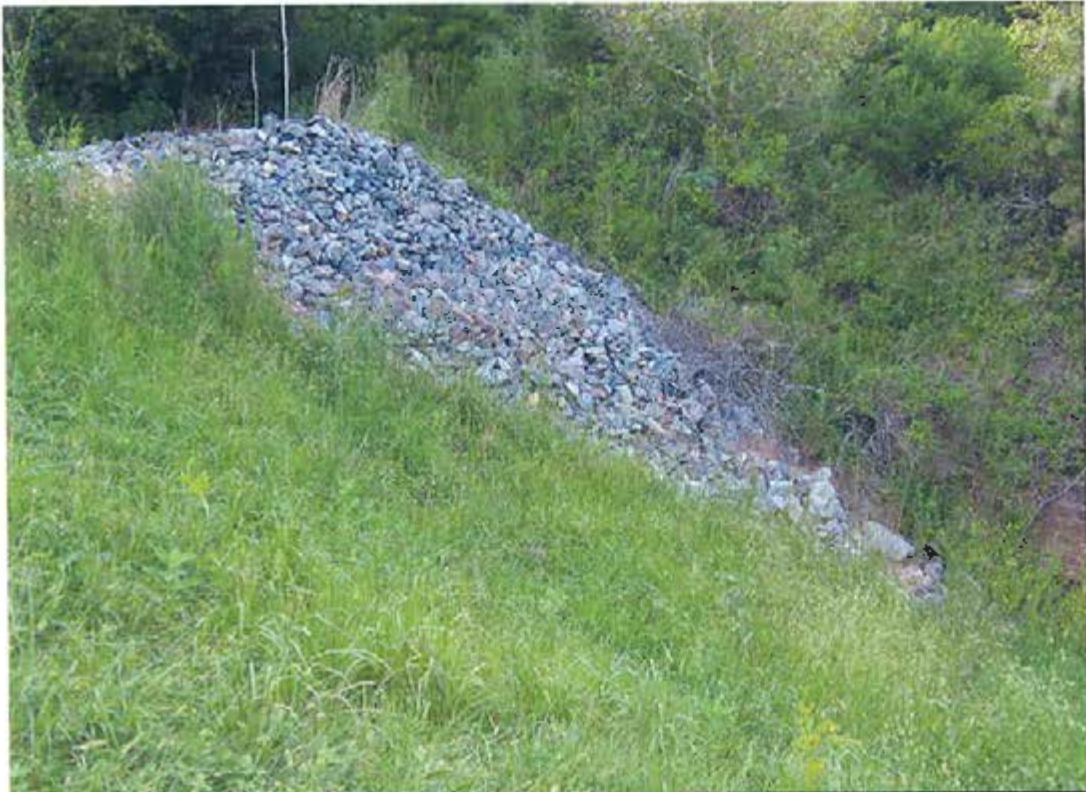
<p>Photograph 4-19</p> <p>Rip-rap blanket over previously repaired slump. Soil erosion continues to occur at toe rip-rap. Note unmowed grass on slope.</p>

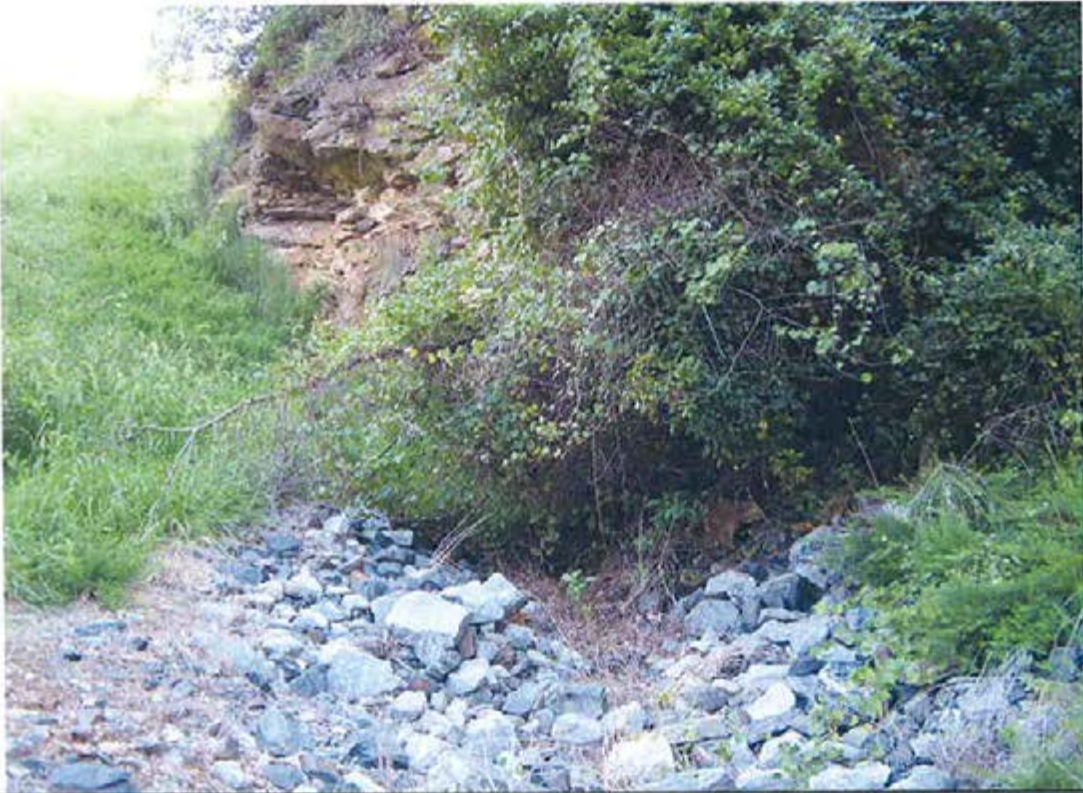
<p>Photograph 4-19A</p> <p>Suck Creek downstream dike, left abutment contact. Weathered rock fallen into rip-rap lined ditch visible in 2001 photograph obscured by vegetation in 2006.</p>
	Remarks
